## LANDSLIDES AND RELATED FEATURES OF THE DALE HOLLOW DAM, TENN.-KY. QUADRANGLE

by  
Alfred R. Taylor and Roger E. Thomas

U.S. Geological Survey  
OPEN FILE MAP 82-653 (E-5)

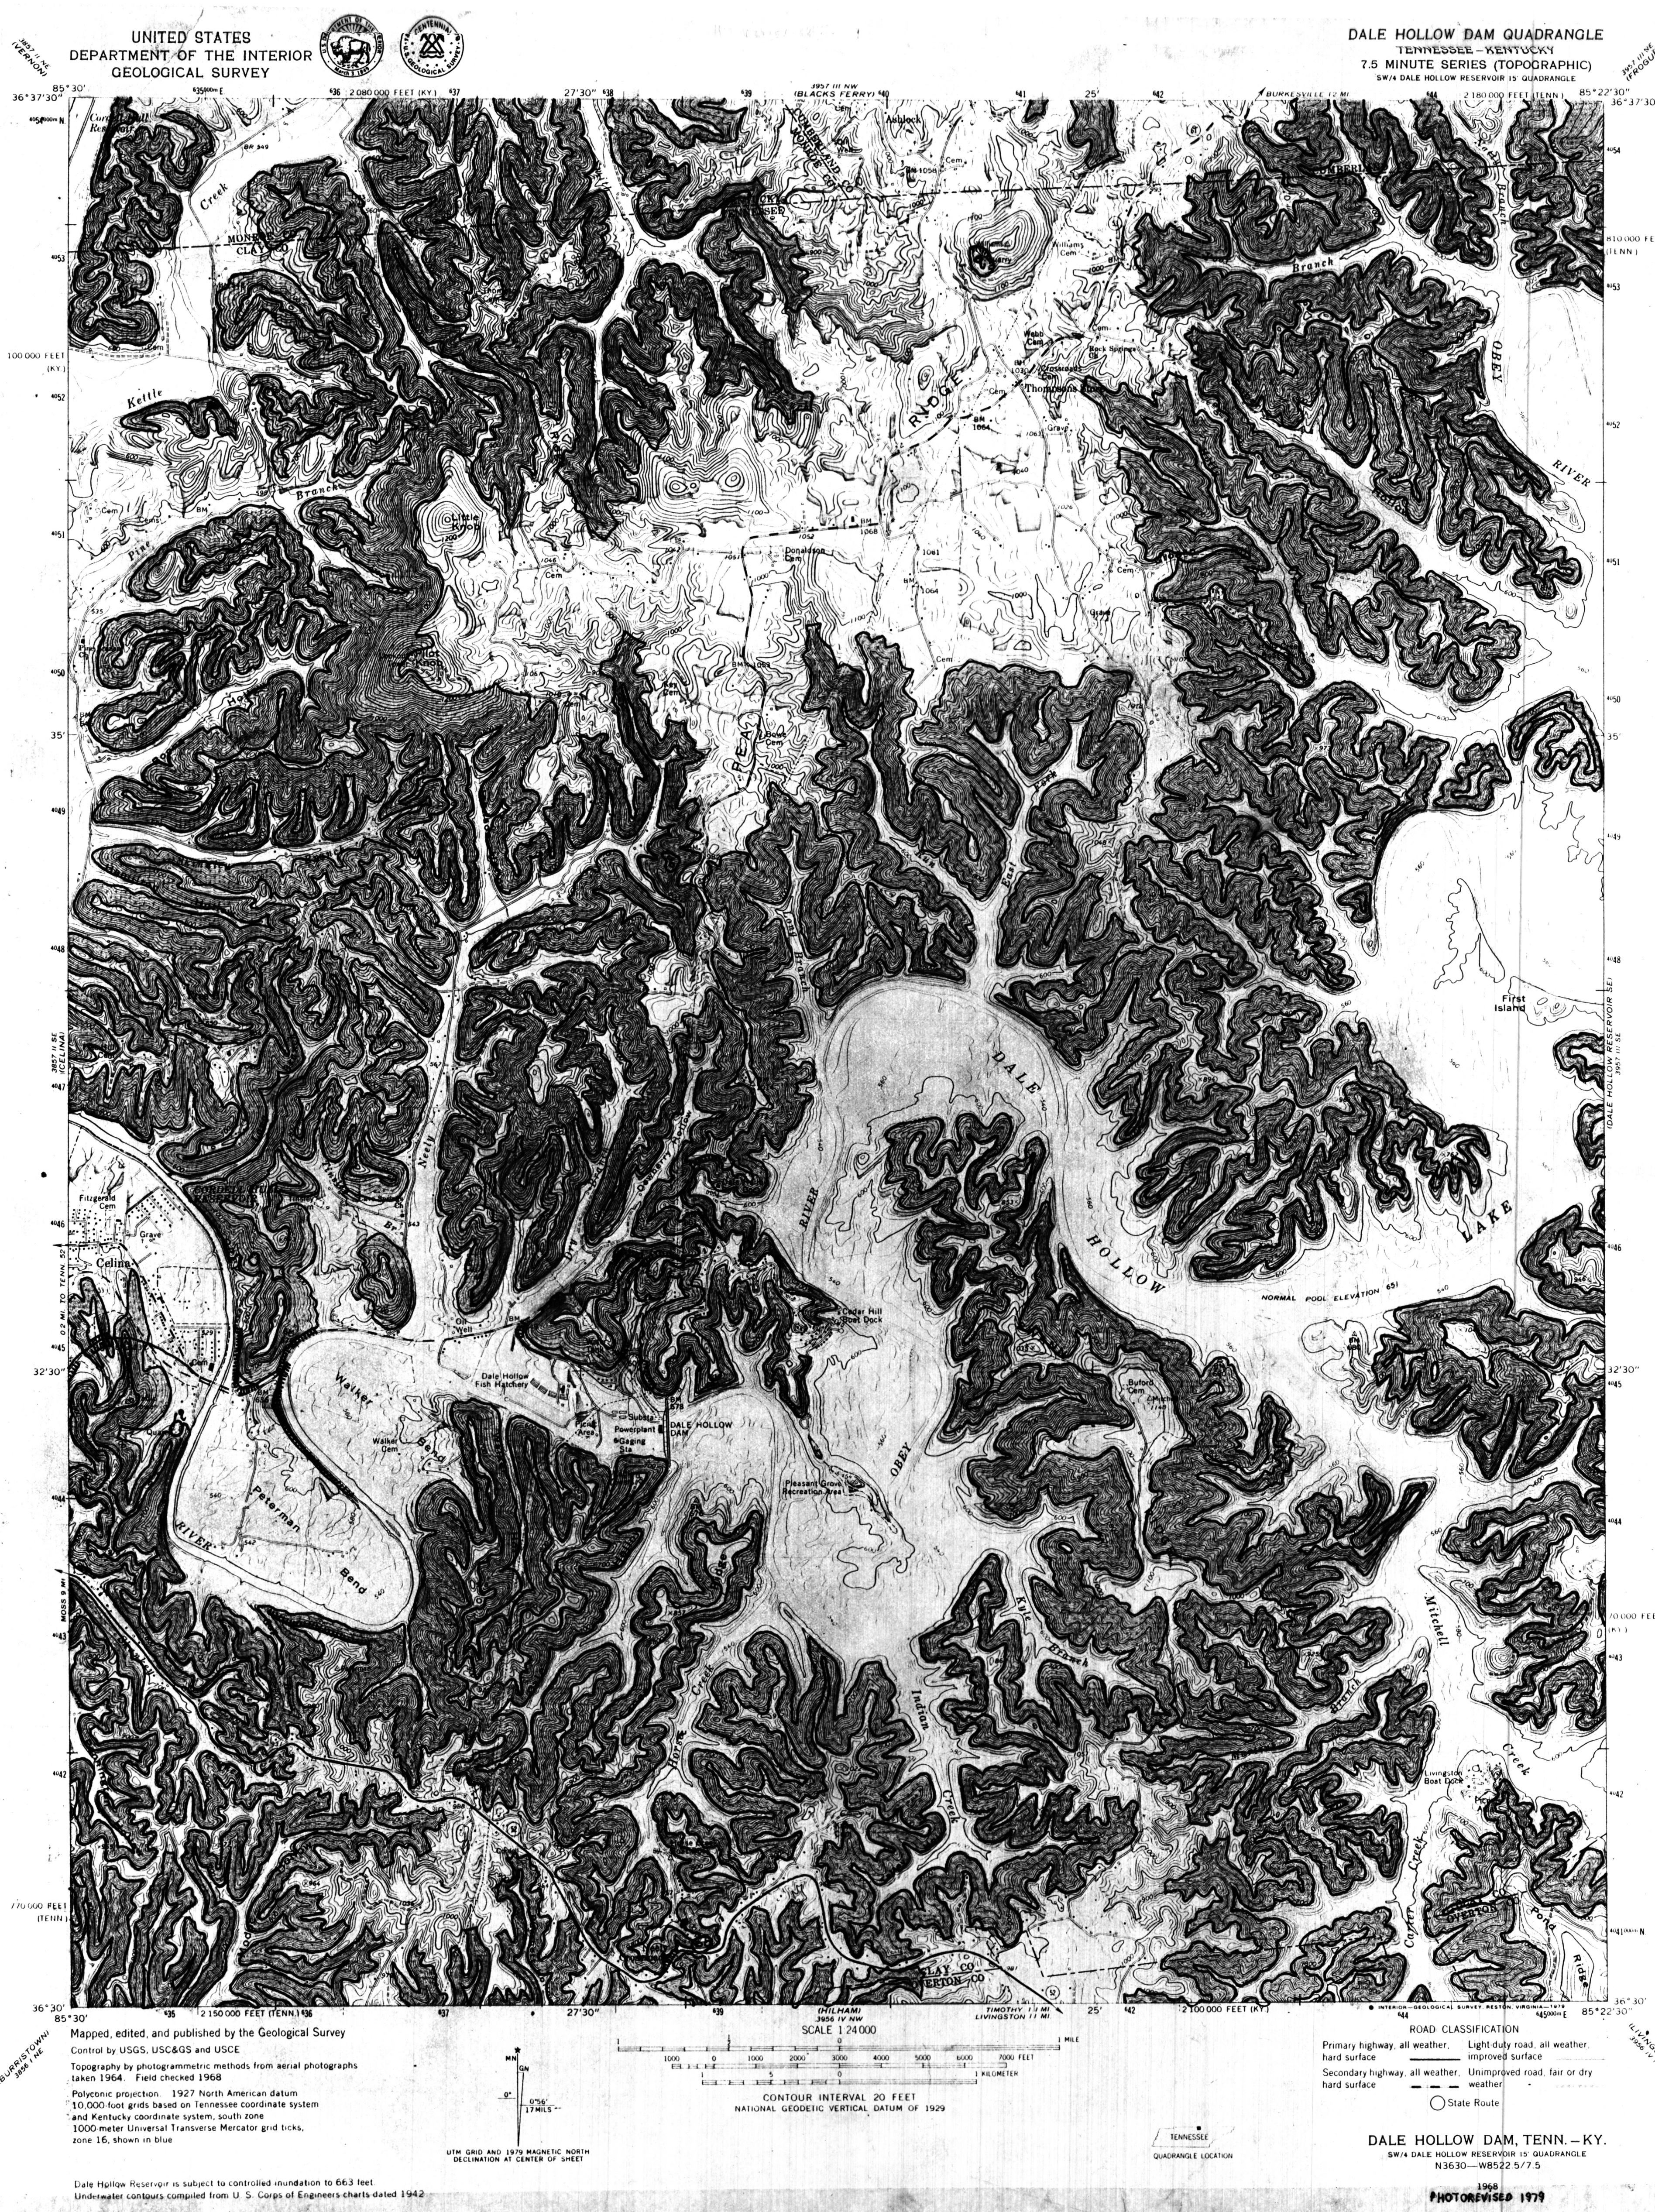
Landslides and related features interpreted from aerial photographs:

1:40,000 (Black and White) 1978  
1:80,000 (Black and White) 1975

Photointerpretation and field check 1979-1980, 1982

Complex landslide composed of earthflow, debris slide, earth and rock slump. Identified from historical records, and from scars, debris and other field evidence. Ground extremely unstable; sliding accelerated by excavation, loading and changes in drainage conditions. May include areas with several active slides too small to be shown separately. Questioned where doubtful.

Area of extensive hummocky ground caused by earthflow and earth and rock slump. Lacks clear evidence of active sliding. Relatively stable in natural, undisturbed state, generally not affected by small structures properly sited in areas away from the edge of the toe; can be reactivated by extensive, rapid excavation, loading, and changes in ground water and surface water conditions. Area of old landslide probably includes recent ones not identified from field evidence or otherwise documented. Upslope boundary of landslide generally defined by modified scarp, but downslope (toe) may be gradational and not well defined. Questioned where doubtful.

Area of recent and old slides in which individual slides are not identified.

Valley wall along major streams with slope as steep as 40° (85%); stony, clayey silt soil up to 50 ft. (15 m) thick; commonly buttressed by a terrace or bench at the toe of the slope; very susceptible to sliding by cutting of toe area, removal of terrace or bench, and overloading; slide commonly activated without apparent cause.

Landslides too small or obscure to map individually.

Primarily shallow, narrow ravines and chutes with accumulation of stony colluvium generally 10 ft. (3 m) or less in thickness; susceptible to rapid movement during intense rainfall. Most ravines and chutes designated show evidence of former debris flows and avalanches.

Steep, locally vertical, natural and man-made slopes and cliffs, 15 ft. (4.5 m) or more high; formed dominantly of sandstone, limestone, sandy shale, mudstone and claystone. Interbedded mudstone, claystone and shale weather rapidly leaving sandstone and limestone rock faces unsupported.

Soil and rock similar to that involved in landslides elsewhere in map area; primarily areas underlain by claystone, mudstone and shale associated with other rock types. Rock weathers rapidly on exposure forming clayey soil highly susceptible to sliding. Includes coves (U-shaped, shallow valleys) containing thick layers of clayey soil that are very susceptible to sliding where excavation breaks continuity of slope and where overloaded by artificial fill.

Map areas in which no patterns or symbols are shown; primarily valley floors, ridge tops and broad benches; modification by excavation and fill may lead to local landslides.
